Project acronym: HEATSTACK
Project full title: Production Ready Heat Exchangers and Fuel Cell Stacks for Fuel Cell mCHP
Grant agreement no: 700564

D5.1 Build of 160 CAPHs using prototype process

Date 4/5/16
Report SFFR1771
Engineer S.Fairhurst
Product Development Director C.Penny
Project Vaillant
Part Name CHP heat exchanger, pn 200-800-262.

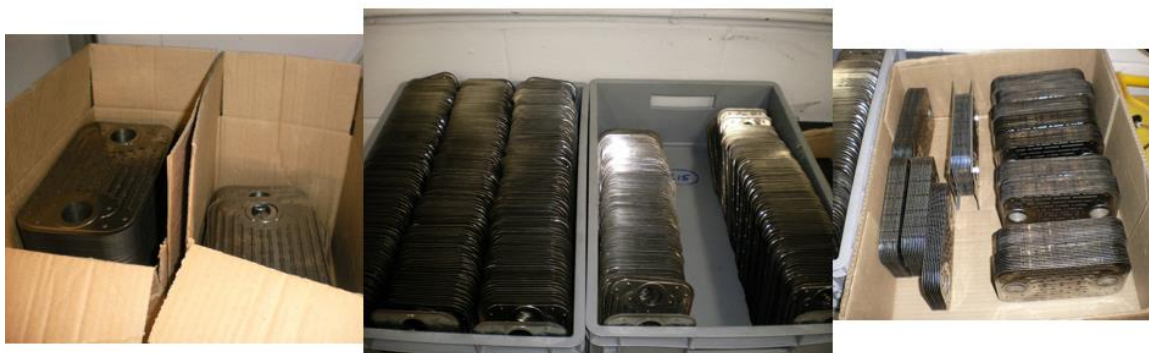
Figure 1

Current stock within the HEATSTACK project

1035 Plates

695 Welded cells

15 Welded stacks.

This material would have been enough to build 116 CAPHs (disregarding scrap).

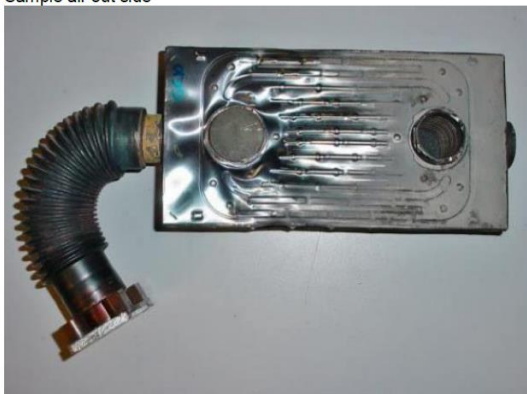
Sample air out side

It was observed that there was distortion of the gas plates around the air in port, despite being at a lower temperature than the air out end, shown by the heat discolouration.

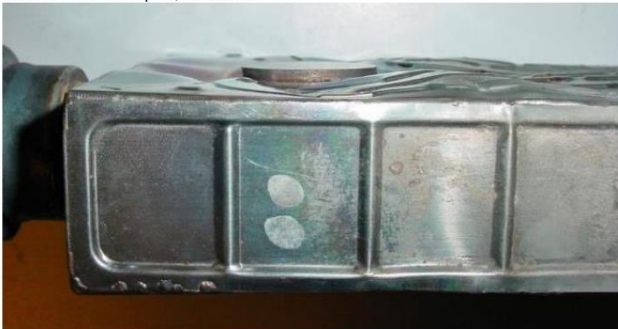
Distortion at air in port, blank side

The returned heat exchanger sample was found to have significant distortion of the gas plates around the air inlet port, despite being at a lower temperature than the air outlet end, as indicated by the heat discolouration. A possible cause of the distortion was insufficient flexibility of the air inlet pipe for the thermal growth of the stack. Modifying the air pipe for increased flexibility of the pipe has been considered.

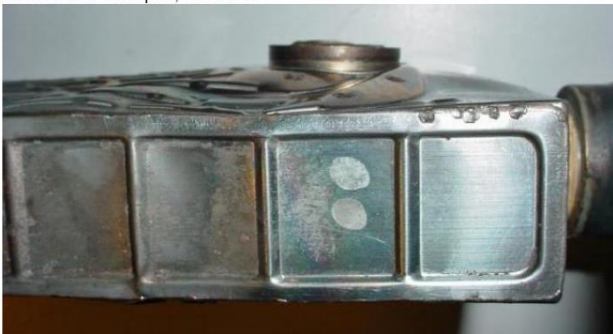
Distortion at air in port, feed side

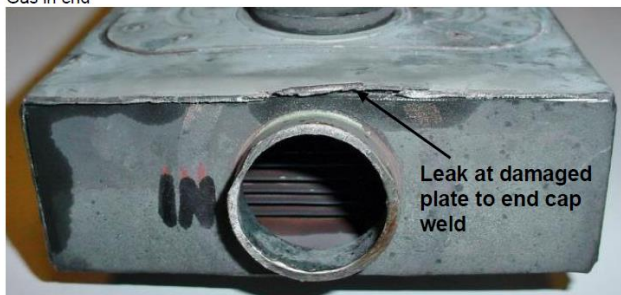
The sample was tested for both gas side and air side with 0.5bar air pressure while submerged in water. The gas side test revealed a leak at an outer gas plate to end cap weld, which appeared to have been damaged. Feedback from the customer suggested the split could have been caused when the sample was removed from the system. No leaks were observed from the air side.

Gas in end

An outer gas plate to end cap weld was found to be damaged and leaking though this was attributed to the sample removal process.

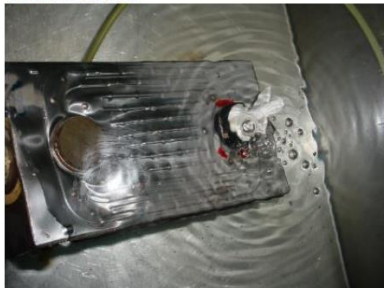
The coolant side test revealed no internal leaks into the gas side. However, there were small leaks from the collars at the air out end which could allow heated air to leak into the atmosphere.

Leak test air side

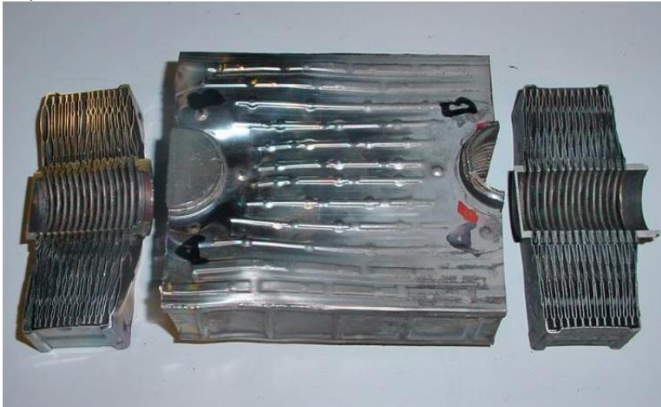
The stack was then sectioned across the air ports to allow the joints to be examined.

Air port sections

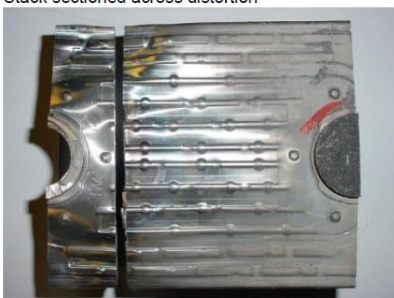
As there appeared to be greater distortion adjacent to the air inlet port, another section was made.

Stack sectioned across distortion

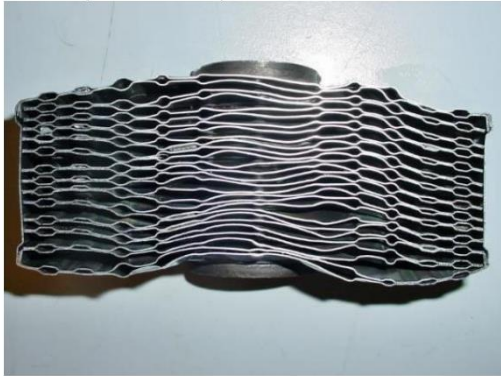
Section adjacent to air inlet port

Despite significant distortion, all the gas plates had intact laser welds at the four dividers sectioned, with air pathways maintained. The distortion had resulted in variable gaps between the gas plate cells, mainly increasing gaps. This would have affected gas flow, though as the gas inlet end had very little distortion, which should minimise the variation in gas flow distribution.

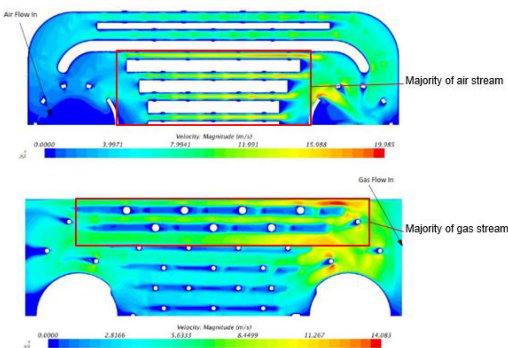
- due to the G6 mounting design and your latest CFD results, we came to the conclusion that the deformation was not caused by external mechanical stress
- most likely the stress within the core pack is generated due to a inhomogeneous heat transfer over the plate
- The oxide layer of the plate indicates the uneven distribution of air to gas stream
- due to the design changes a higher air flow rate through the middle section of the plate is generated. The gas stream travels more likely on the outside due to the increase channels (see pictures next slide)

CFD results on the new plate design
